013643 RRDE-3A Shaft assembly Ver.2

How to replace the RRDE-3A Shaft assembly, use following tools.

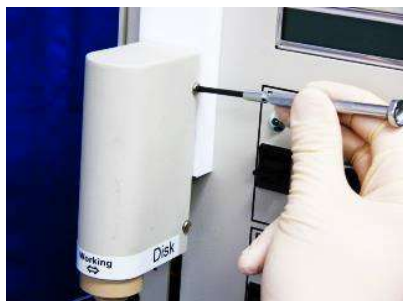
- 1.Remove the screws by using the Phillips screwdriver(#1) for detaching the cover of motor unit.

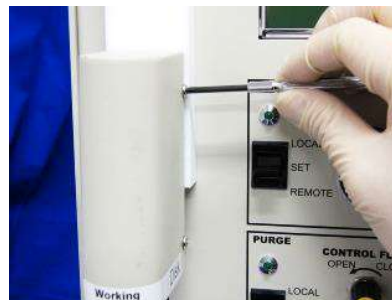
- 6.If there is nothing abnormal behavior, fix the motor cover by 4 screws.
